COMMONWEALTH OF KENTUCKY BEFORE THE PUBLIC SERVICE COMMISSION

KENTUCKY UTILITIES COMPANY)
) CASE NO. 98-275
ALLEGED FAILURE TO COMPLY WITH)
ADMINISTRATIVE REGULATION)
807 KAR 5:041. SECTION 3	Ì

UTILITY ACCIDENT INVESTIGATION REPORT

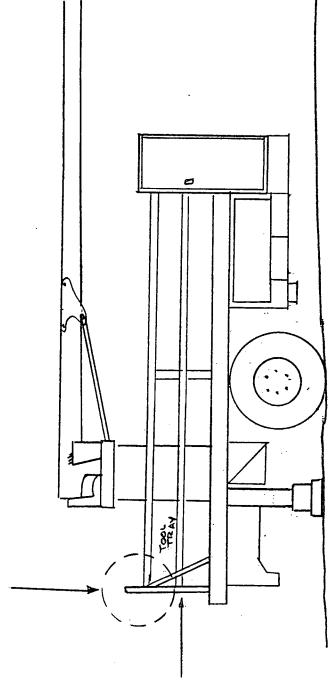
APPROXIMATE LOCATION OF WHERE HAND CAME INTO COUTACT WITH TRUCK,

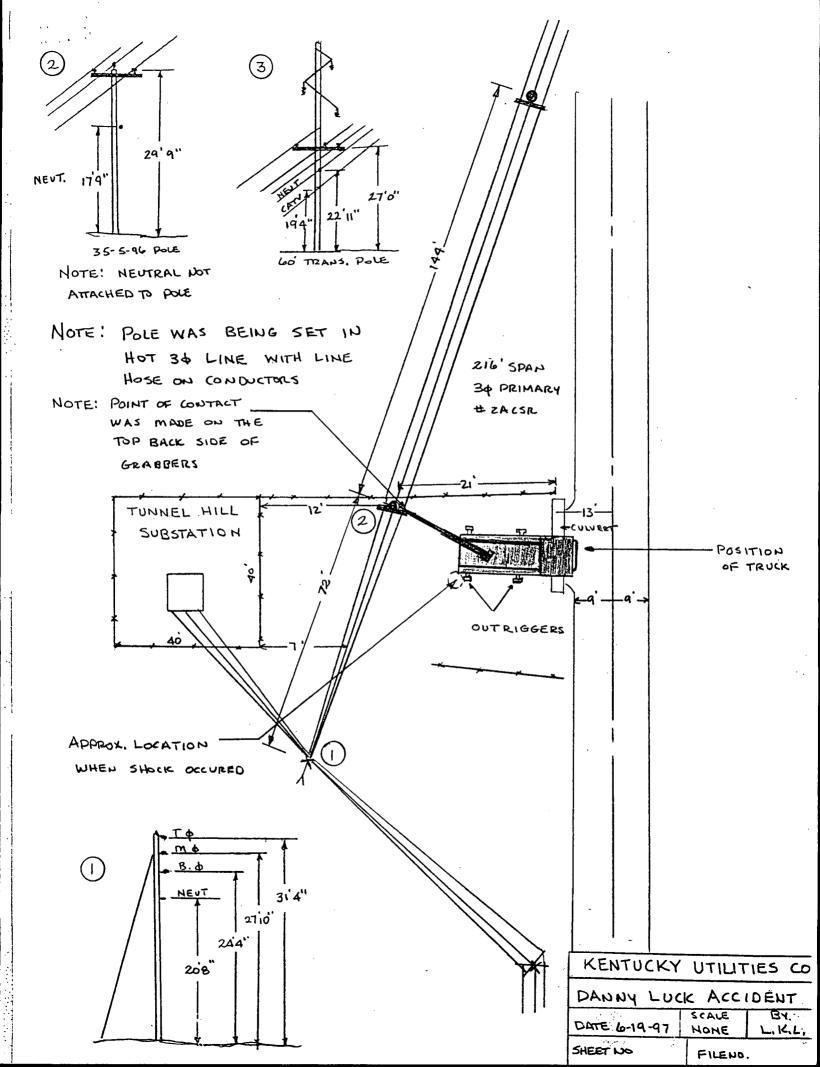
TAM PPER Put Here POINT OF COUTACT WITH LINE ON BACK SIDE
